Buro Happold

Queen Elizabeth Olympic Park

Water Framework Directive Assessment

31 March 2014

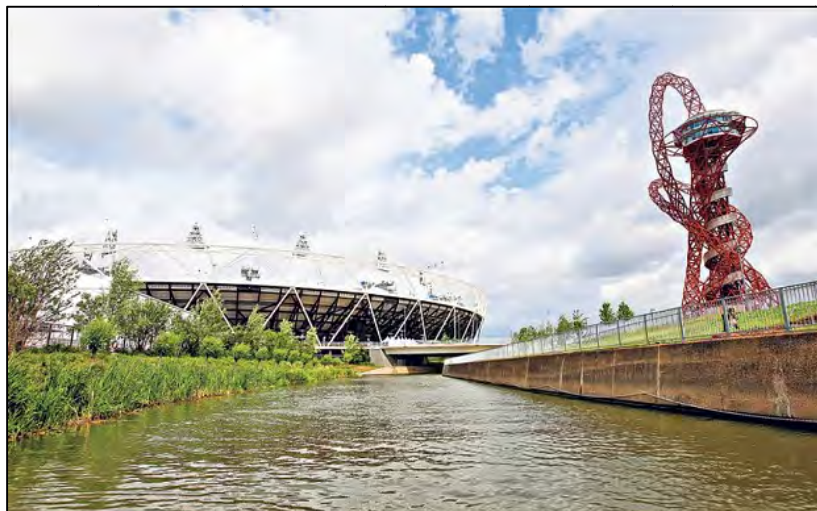
Extensive river bank works were carried out on the Old River Lea and the City Mill River where hard, vertical walls were removed and replaced with shallow sloping, planting river banks.

Figure 7 - Soft river enhancements along the west bank of the City Mill River

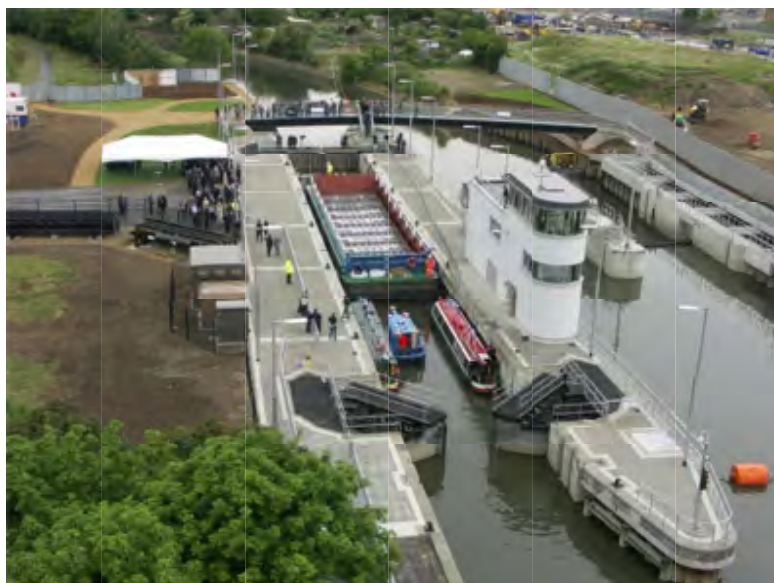
Figure 12 - Three Mills Lock

The creation of the lock means that the River Lea is no longer tidal between Sluice Bridge and Three Mills Lock.

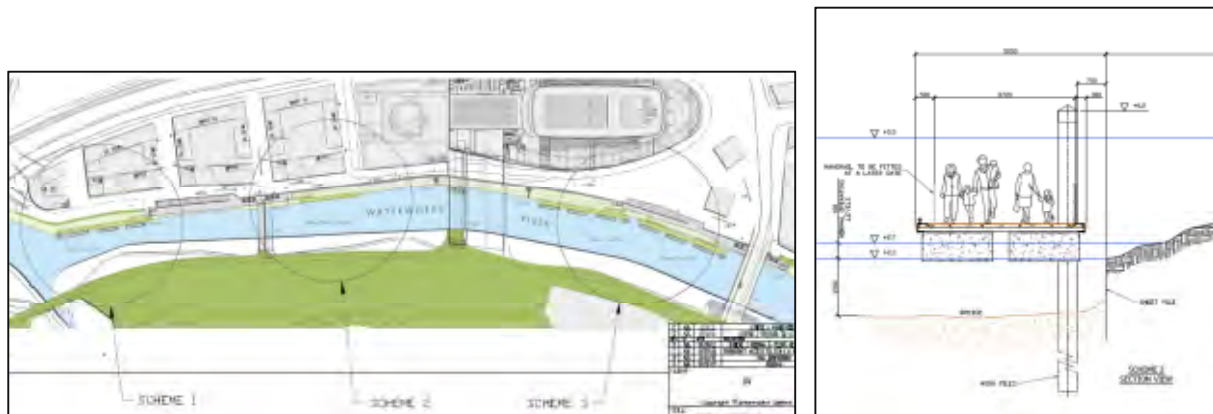
A number of floating pontoon structures, for moorings, is proposed along the east (left) bank of the Waterworks River, in the vicinity of the Aquatics Centre. The works are referred to as Scheme 1, Scheme 2 and Scheme 3 pontoons. Scheme 2 pontoons were in place for the 2012 Games and Scheme 1 and 3 pontoons are expected to be in place during 2014.

Figure 13 - Section through Scheme 2 pontoons

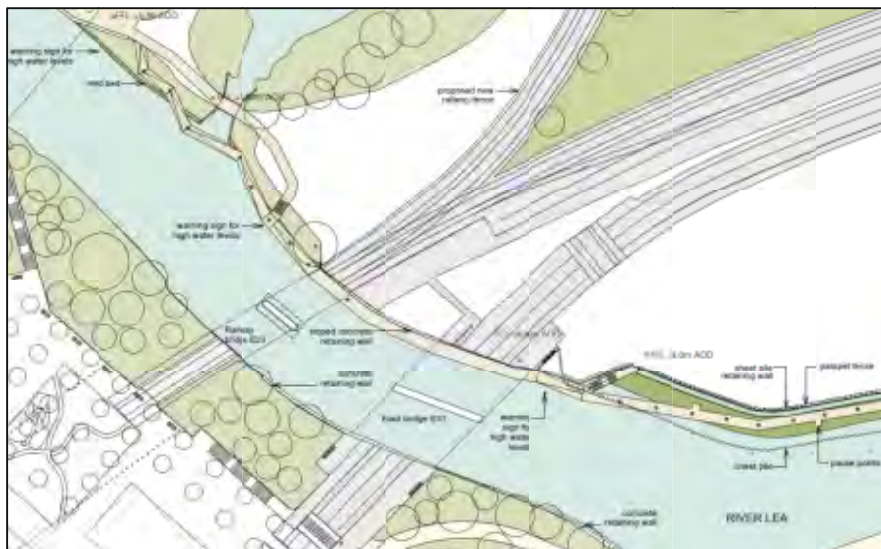
U13/14 is a proposed underpass that will provide pedestrian access along the east bank of River Lea below bridge E29 and E31.

Figure 15 - U13/14 Location Plan

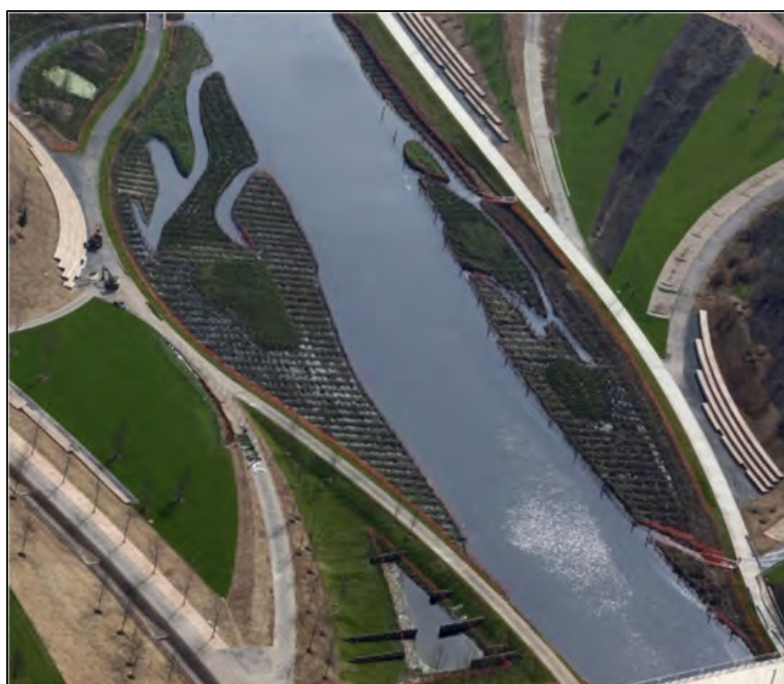
Figure 17 - Reed beds shortly after construction in 2011

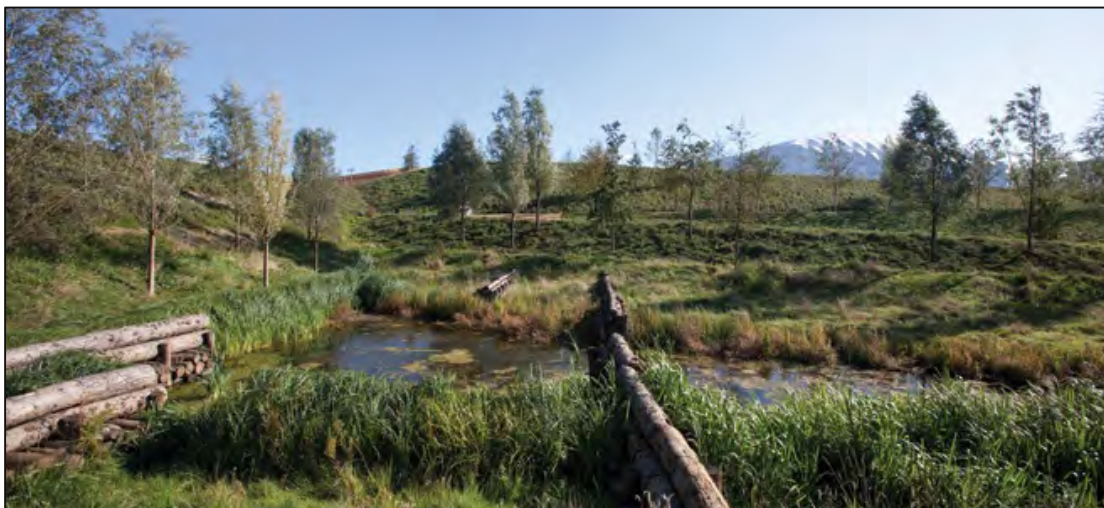
Two new wet woodlands, over an area of 4,000m², provide off-line river habitat, with excavated channels maintaining hydrological and ecological connectivity with the River Lea. These areas have been designed to retain waters from the Lea during periods of higher retained level as a result of Three Mills Lock. The wet woodland habitats have been planted with a mix of shade tolerant sedge species and typical wet woodland trees such as alder. Shallow depressions provide areas of standing water that provide a range of moisture gradients across the habitat. Marginal wetland flowering plants add further value to the area.

Figure 19 - Wet woodland habitat at Bully Point

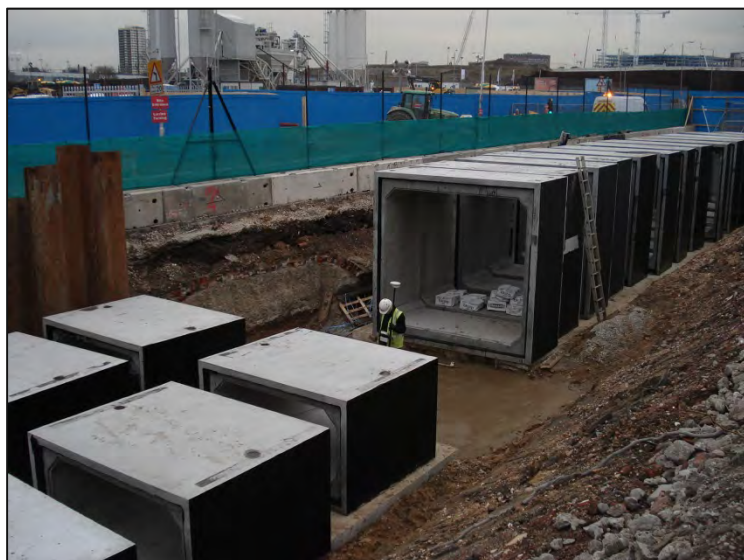
Figure 20 - new culverts ready to be placed (May 2009)

In 2009 Channelsea Gorge was culverted (3m x 2.75m) as part of the October 2008 Parklands & Public Realm application that included the wetland bowl and concourse works to the east of the River Lea.

At the same time of the culverting of Channelsea Gorge a second culvert (2 x 1m) was added to Hennicker's Ditch Extension to increase flow from the overland flow route to the River Lea, via U01.

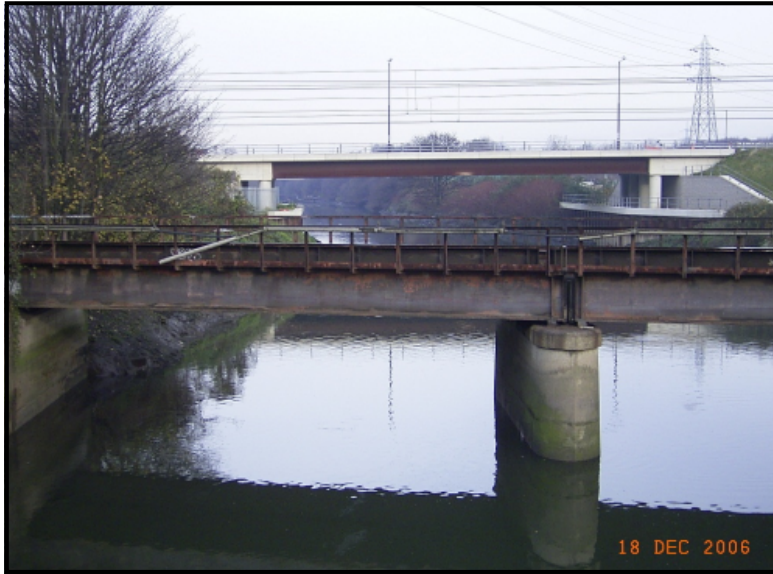
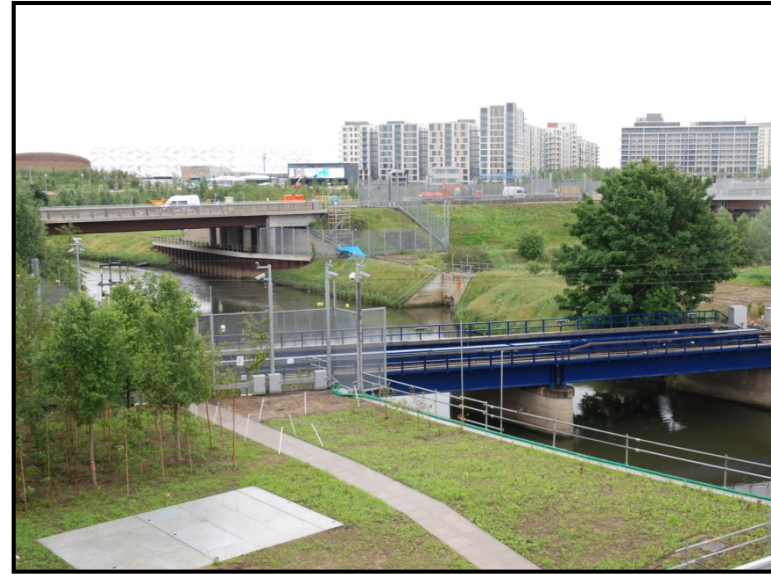
Description: Looking North along the River Lea, upstream of Carpenters Road.

Then: Undergrounding works removed pylons in background (north of A12). Vegetation around Bully Point and the Channelsea River visible.

Now: Fully transformed Rail Bridge (blue). Olympic Village in the background (East).

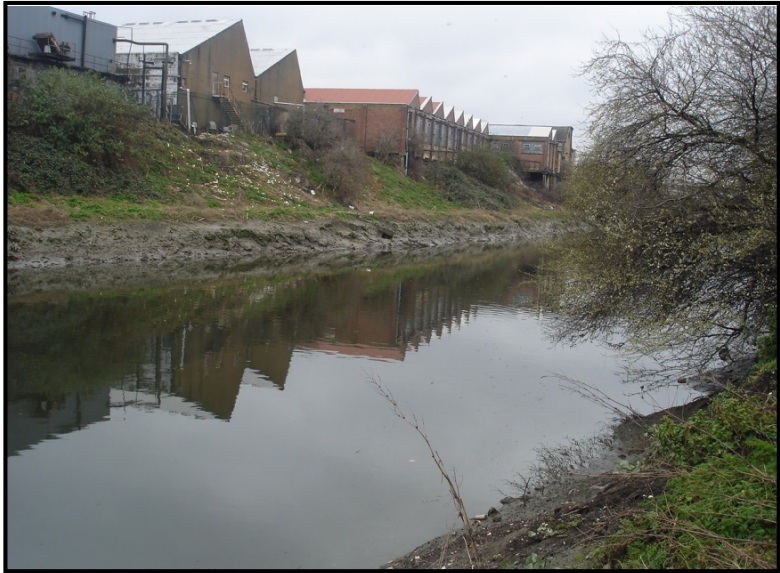
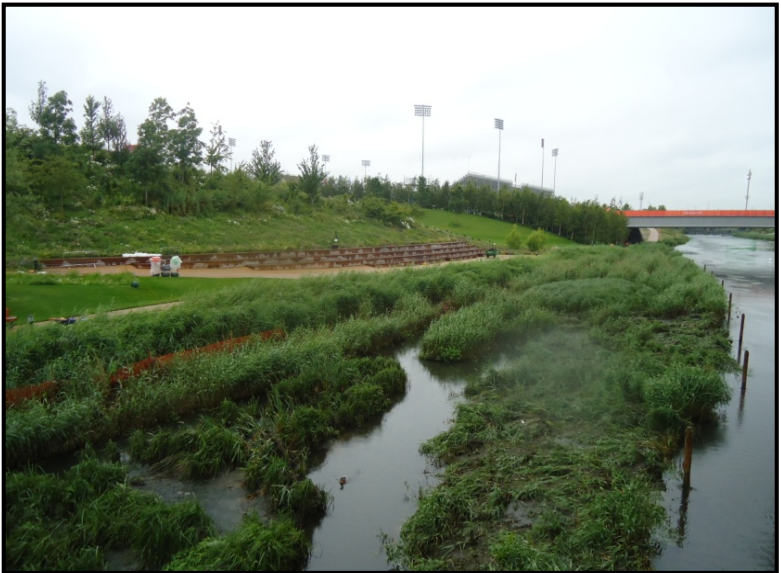
Description: River Lea looking upstream in the north of the Park.

Then: Bus depot along on west bank. High water silt marks visible.

Now: Reed beds on the west bank part of the Wetland Bowl. Riverside Stadium (Hockey) in background left. F02 in background.

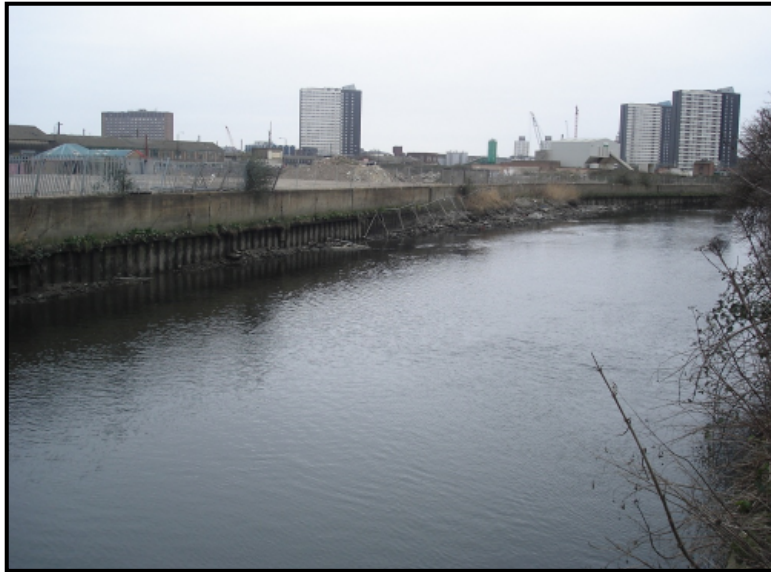
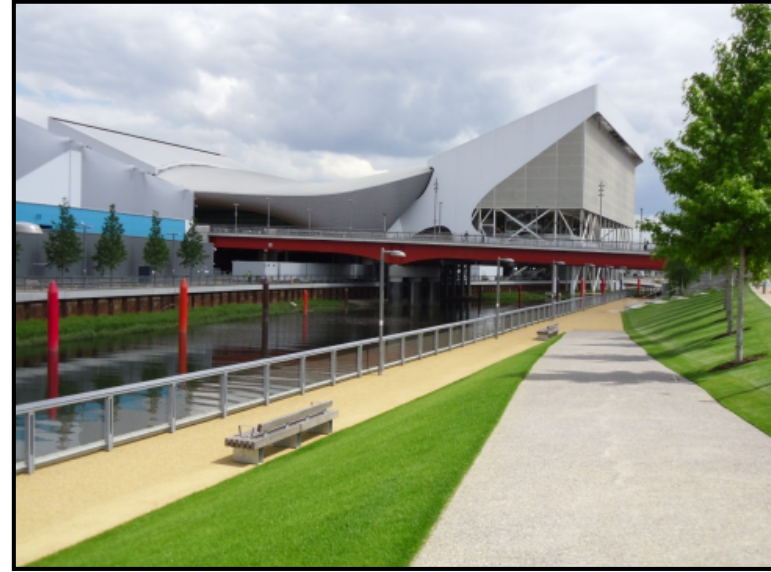
Description: Waterworks River, looking south.

Then: Highly contaminated Brownfield land on east bank, previous scrap metal and car servicing. Poor wall piling was worsened by tidal influence.

Now: Aquatics Centre and Water Polo Arena in foreground. Note British Waterways mooring posts in front of riverside planting on far bank.

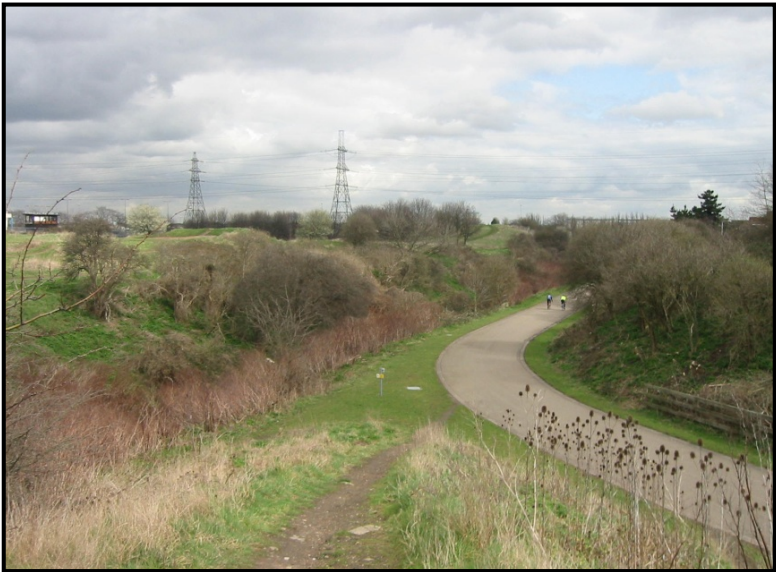
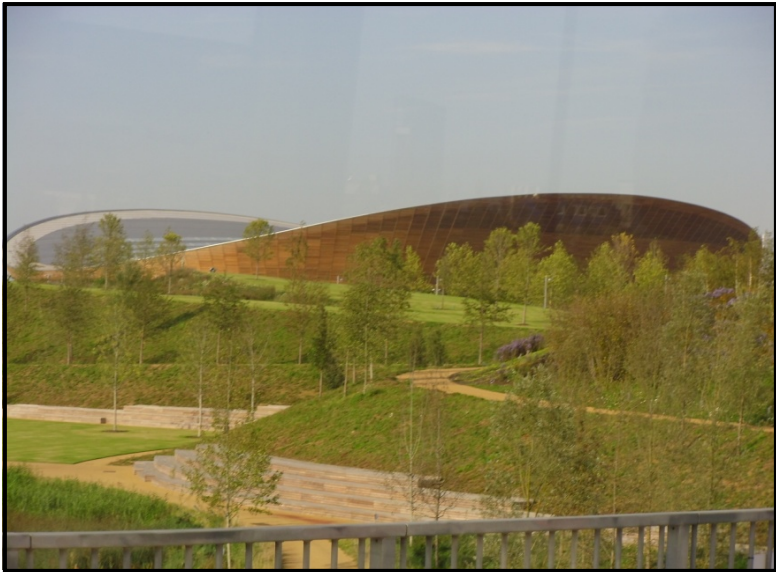
Description: Looking North along the line of Channelsea Gorge.

Then: Channelsea Gorge along line of trees/shrubs on the left hand side, infested by Japanese knotweed. Site of the Lea Valley cycle path.

Now: Channelsea Gorge now culverted and landscaped over. Velodrome in background.

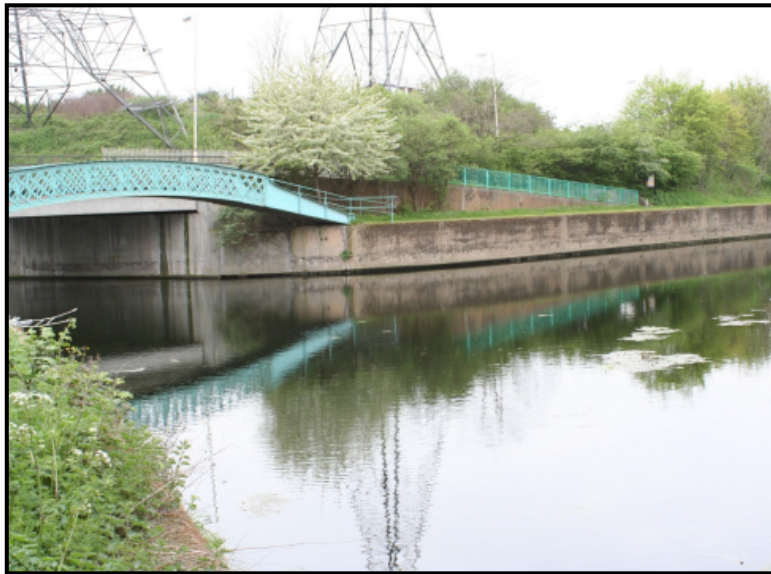
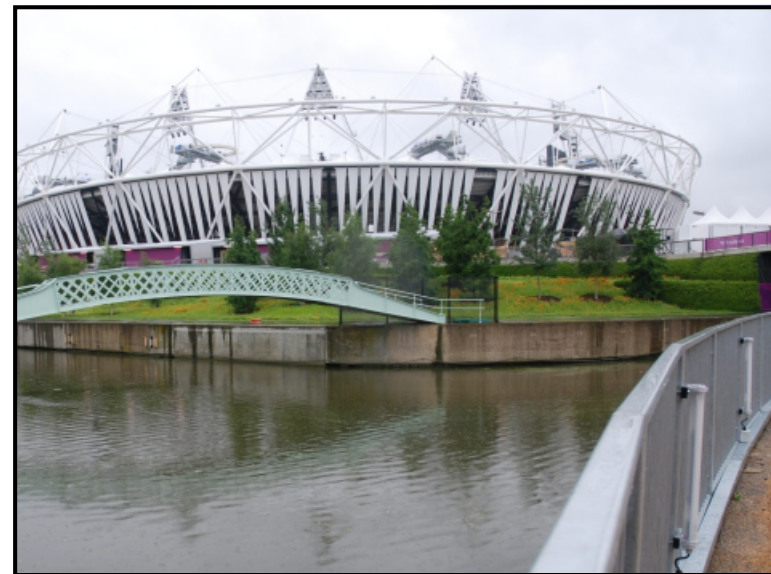
Description: Diffluence of City Mills River (left) and the Old River Lea (right), located North of Zone 3.

Then: High voltage overhead lines, cables now buried in tunnels underground as part of the enabling works.

Now: The triangles of the structure of the Olympic Stadium replace the triangles of the pylons. Restored green bridge, north of the stadium, spans the head of the City Mills River.

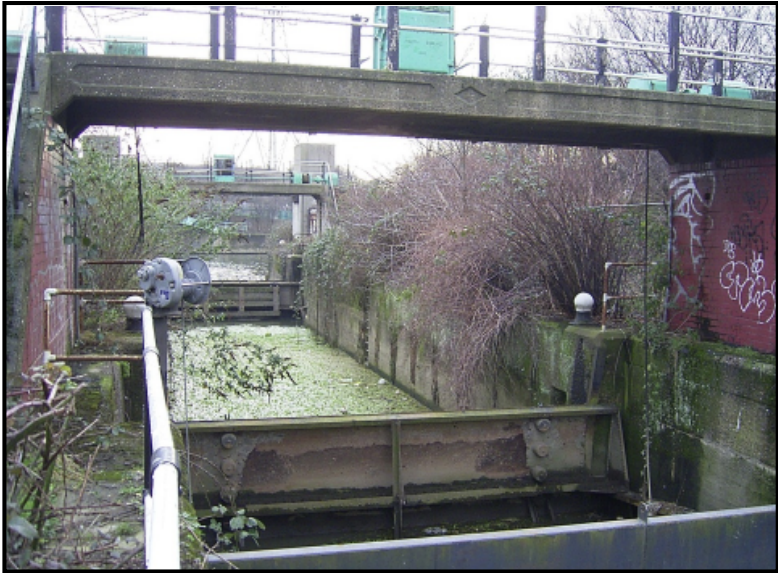
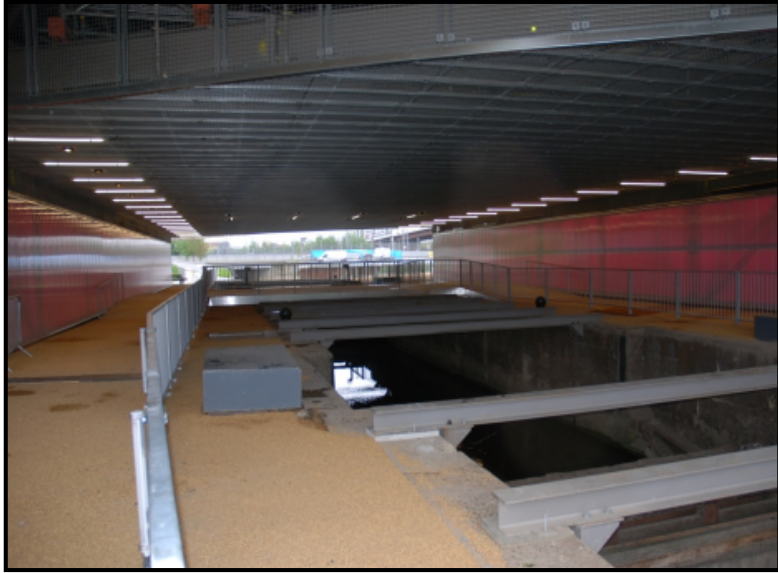
Description: Carpenters Road Lock, looking north along the River Lea.

Then: Carpenters Lock in state of disrepair and no longer in use. Important in that it retained the Bow Back Rivers level from the Waterworks River.

Now: The large land bridge built over the lock with rubber footpath (pictured right) on top lies just north of the Olympic Stadium.

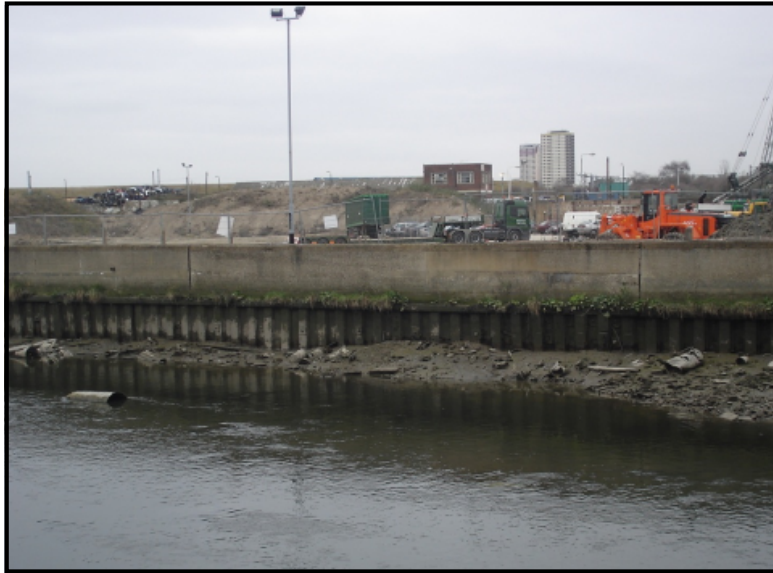
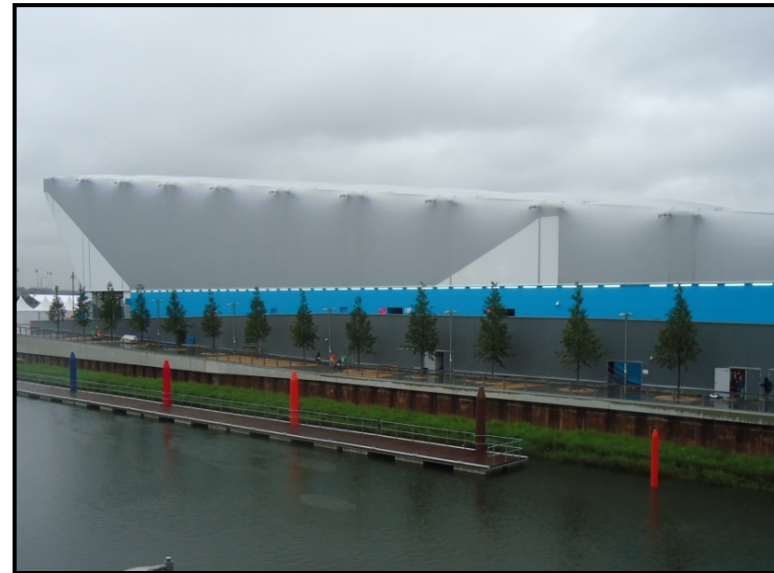
Description: View across the Waterworks River to Zone 1.

Then: Contaminated site with poor quality pile cap and unsightly silt.

Now: Water Polo Arena (Temporary structure) and BW ship impact protection posts and mooring pontoon.

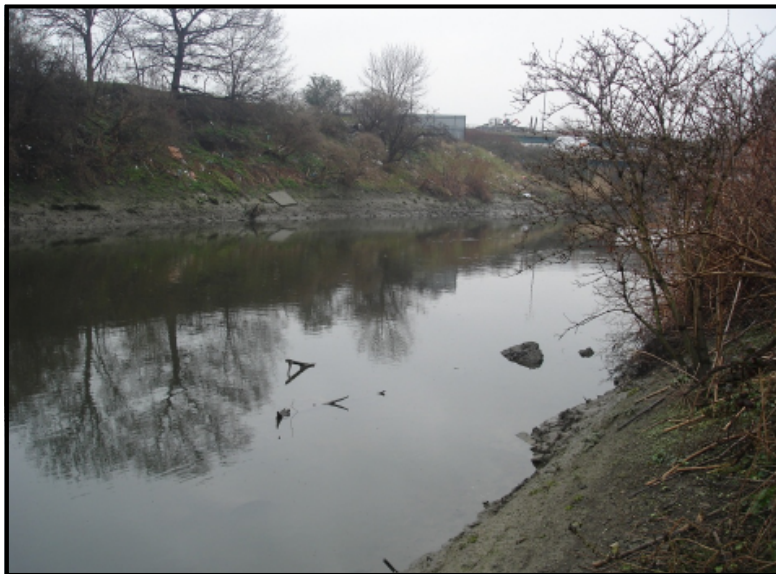
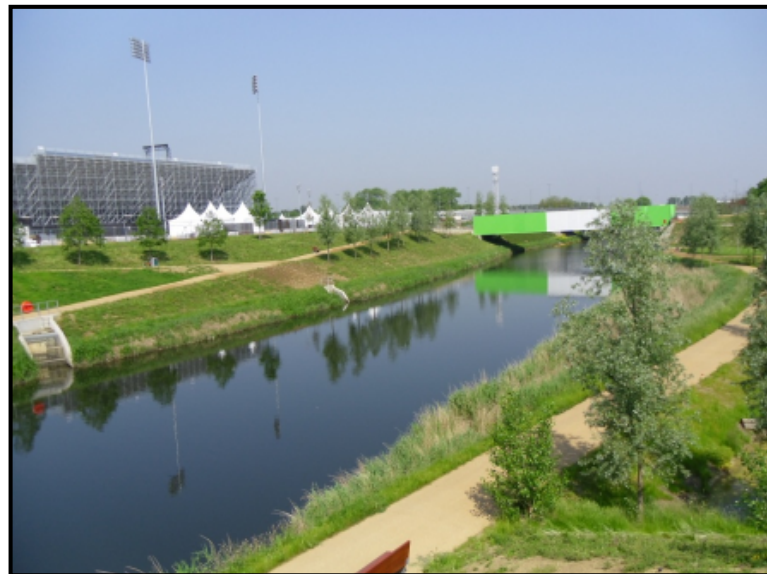
Description: Looking upstream along the River Lea.

Then: Travellers site and warehousing adjacent to the bus depot built on war-time bomb damaged material.

Now: Riverside Stadium (Hockey) on west bank with new footbridge, Y01, across the River Lea.

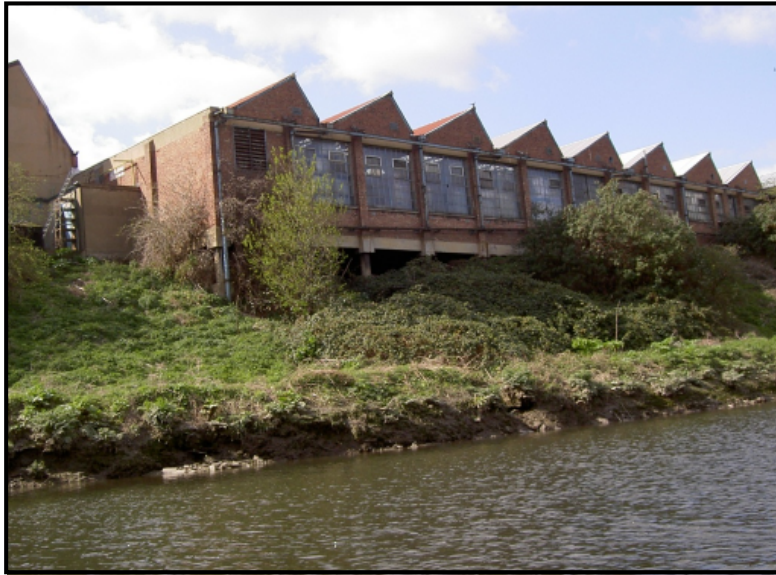
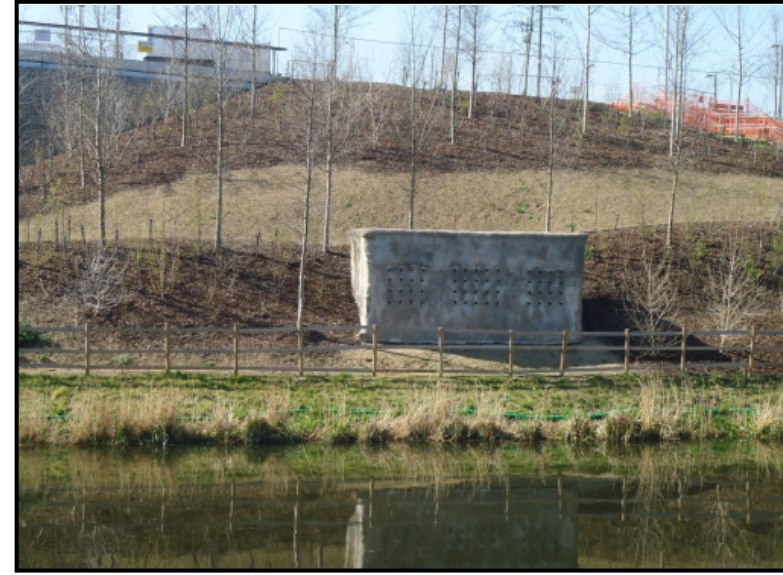
Description: Looking towards the west bank (right) of the River Lea.

Then: The bus depot, the river bank showing signs of significant slip circle damage.

Now: Landscaping along right bank and “affordable housing” for Sand Martins.

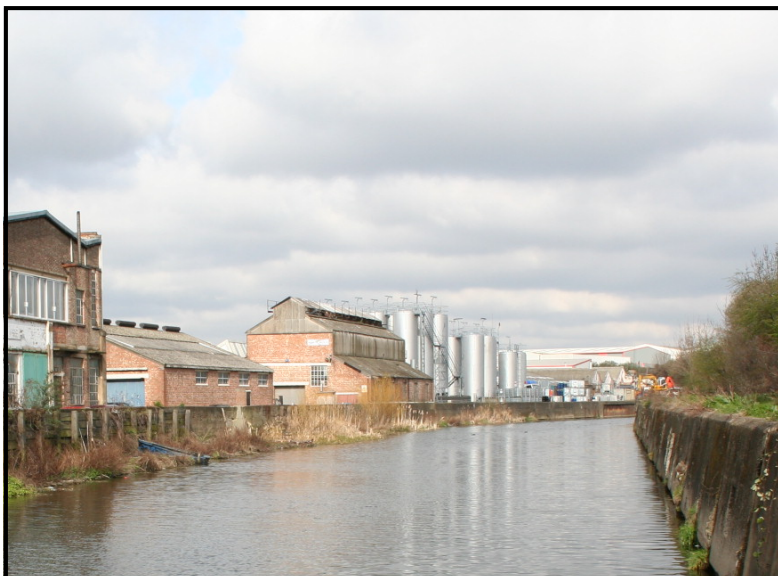
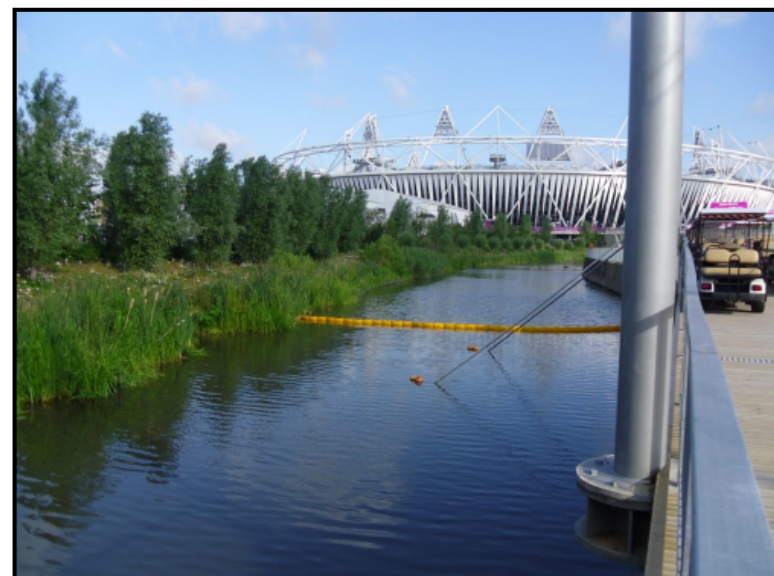
Description: City Mills River looking upstream.

Then: Chemical works with highly contaminated ground conditions behind a river wall/flood defence in very poor condition.

Now: Soft landscaping on west bank in place of the chemical works. Olympic Stadium in the background.

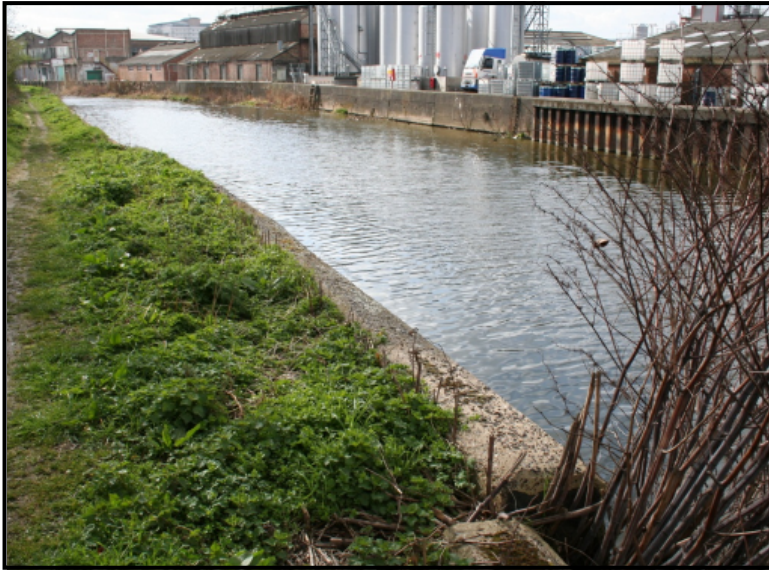
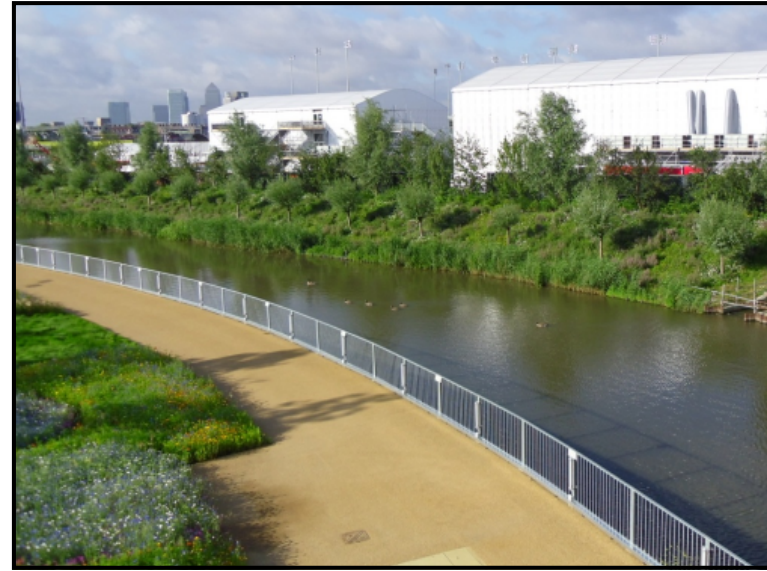
Description: City Mills River, looking downstream.

Then: The chemical works and industrial land site on the west bank of the City Mills River. East bank river wall showing signs of rotational failure.

Now: Main Stadium area “back of house” along the west bank.

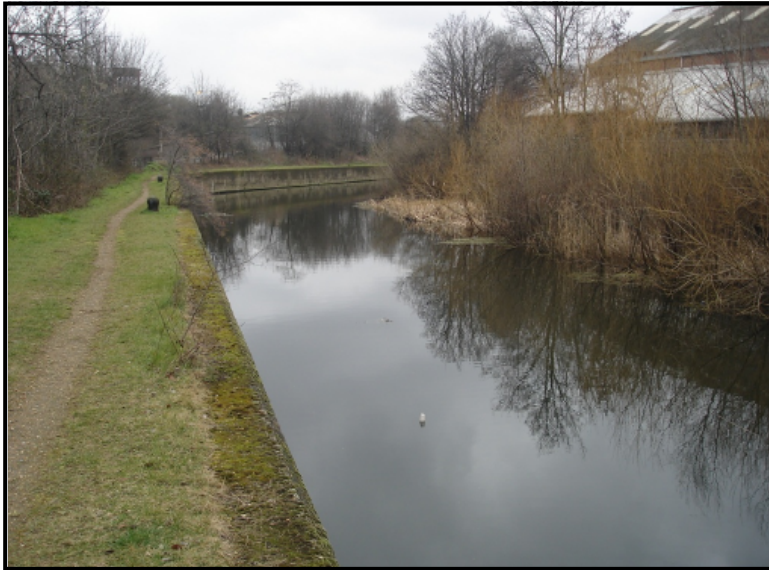
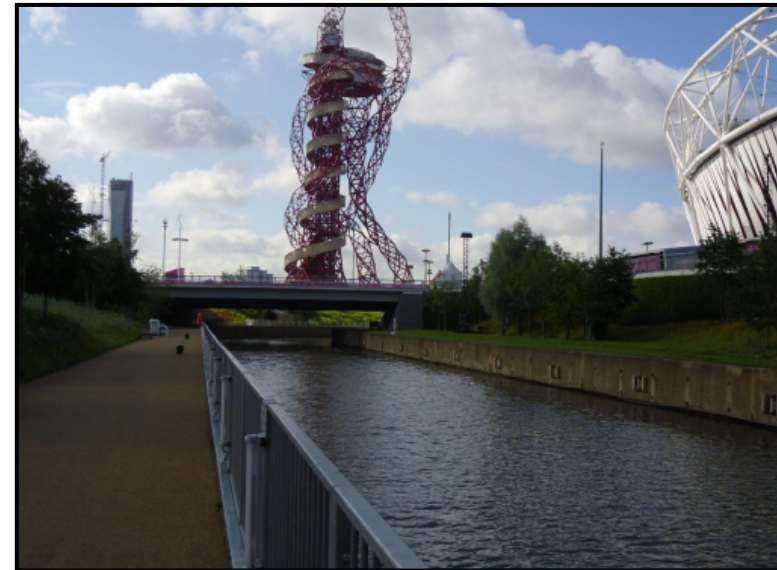
Description: City Mills River looking downstream.

Then: Sun Wharf site on the west bank.

Now: New bridge, F11, across the river in front of the 115m high ArcelorMittal Orbit (Architect: Anish Kapoor) and the Olympic Stadium on the right, in place of Sun Wharf.

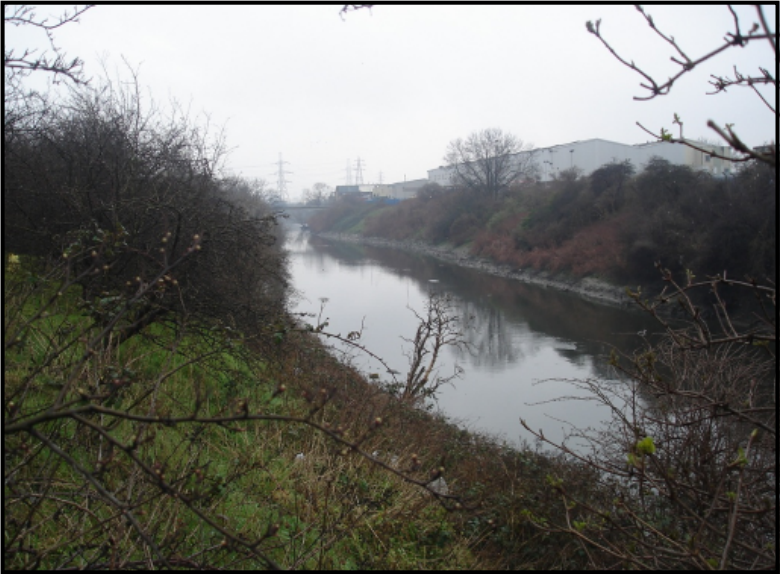
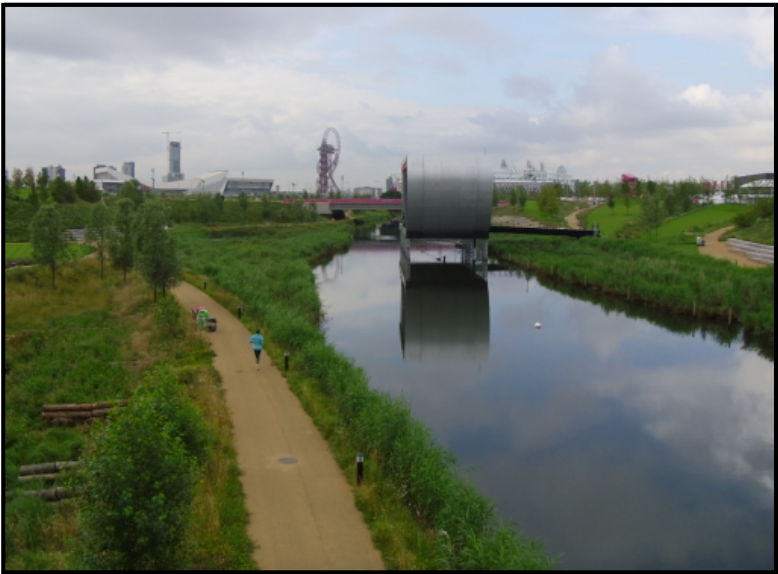
Description: The River Lea looking downstream in north of Park.

Then: Photo viewed from the Lea valley cycle track. The bus depot is visible on the west bank.

Now: The BA Live Site in the Wetland Bowl. ArcelorMittal Orbit and the Aquatics Centre (left) in the background.

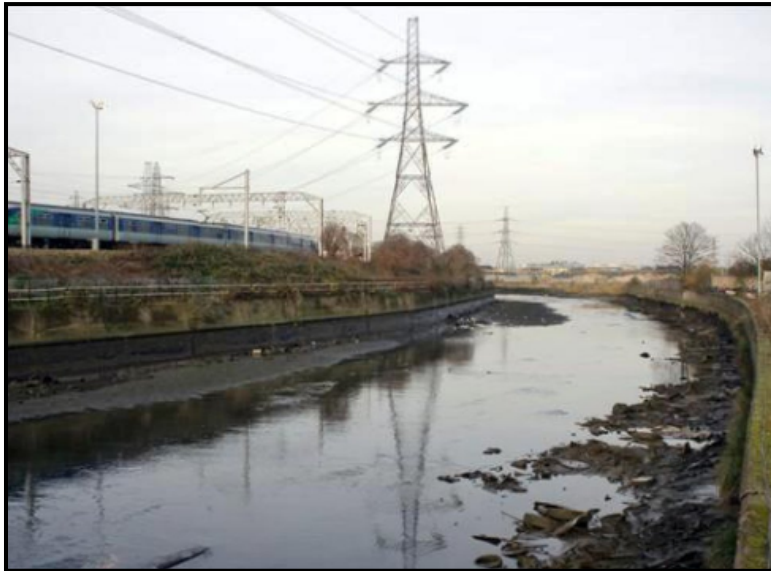
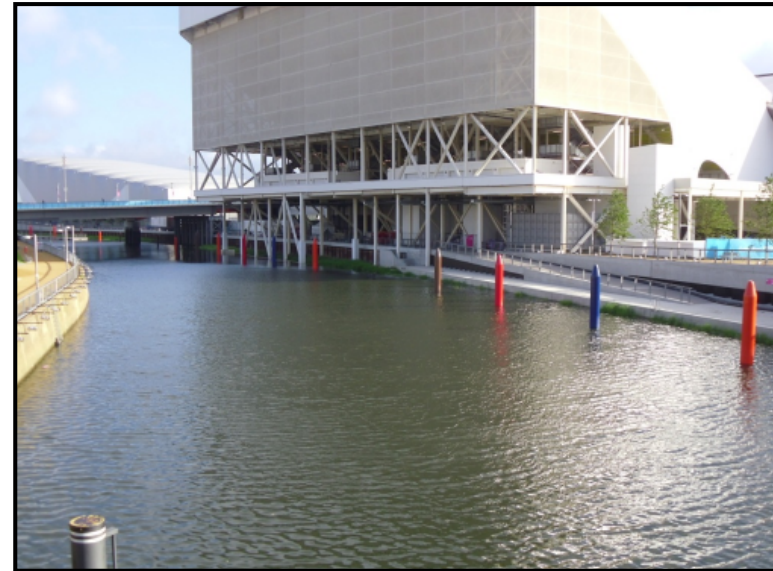
Description: Waterworks River looking upstream.

Then: Network Rail Thornton Fields train sidings produced contaminated land. Waterworks River tidally influenced. Viewed at low tide.

Now: One of the Aquatics Centre seating wings (temporary) on the east bank with Bridge F10b and Water Polo Arena (temporary) in the background.

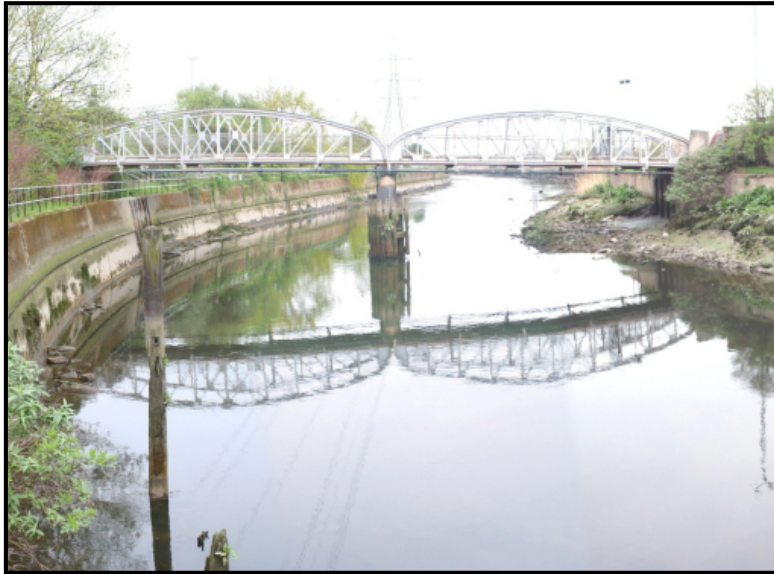
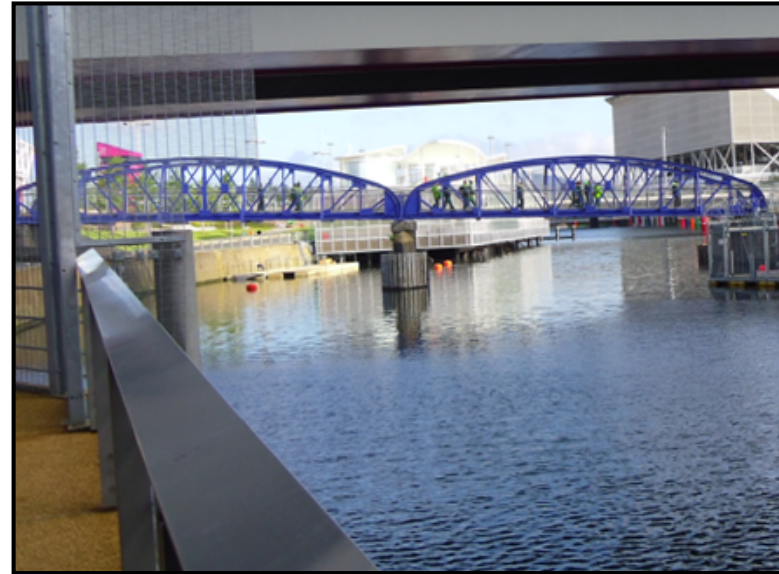
Description: Waterworks River looking upstream from southern end of Zone 1.

Then: Footbridge, E41, in poor condition and west bank river walls unsightly. East bank showing signs of slope instability.

Now: Waterworks River, now non-tidal, flows past the Aquatics centre on right east bank.

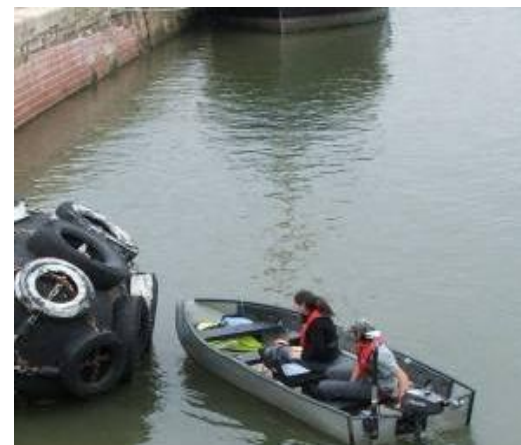
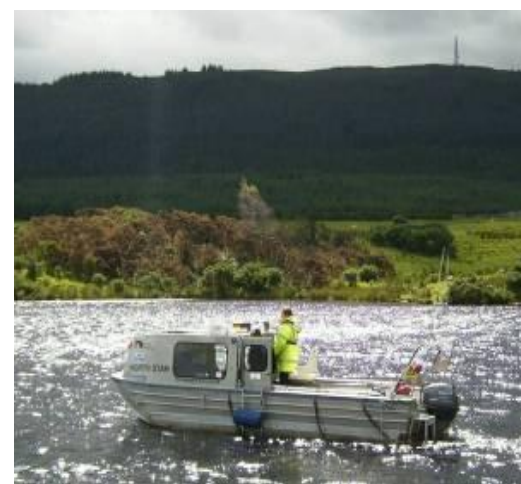
The Trusts Dredging Strategy Onboard Display

Scanning Sonar Profiler surveys

- GPS Controlled Scanning profiler - collects a 'swathe' of data across the canal bed. Many 1000's of points.
- Allows extraction of cross sections extracted at any point
- Cross section data used to calculate Dredging Priority Trigger (DPT) compliance

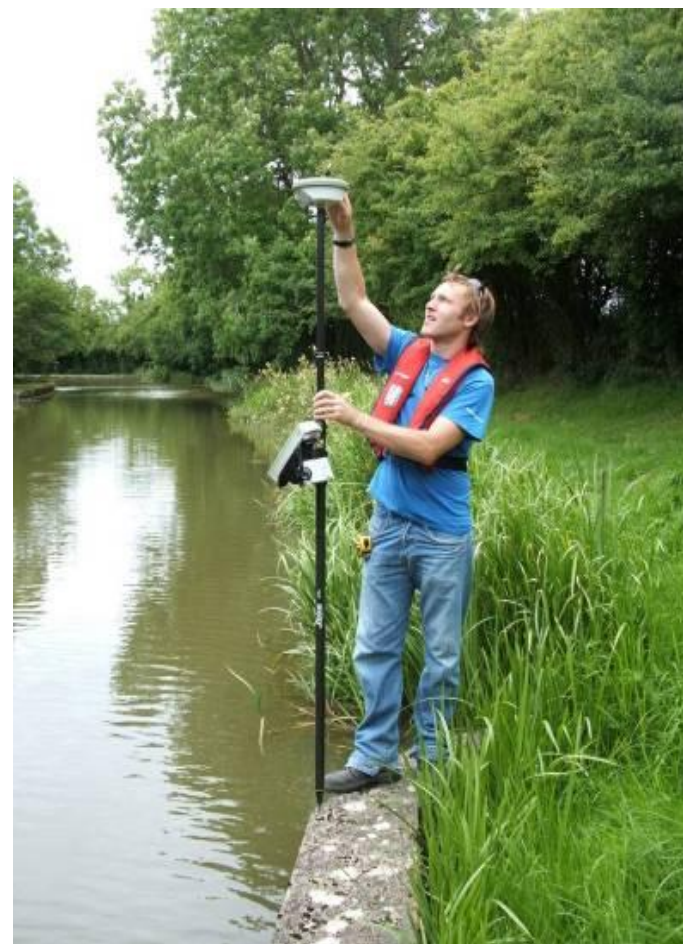
The Trusts Dredging Strategy Establishing Normal Water Level

- Controlling water level established to ensure accuracy and repeatability of survey.
- GPS height and position found on controlling weir, to accuracy of <math><20\text{mm}</math>.
- Currently levelling all the weirs across the network. 958 so far.

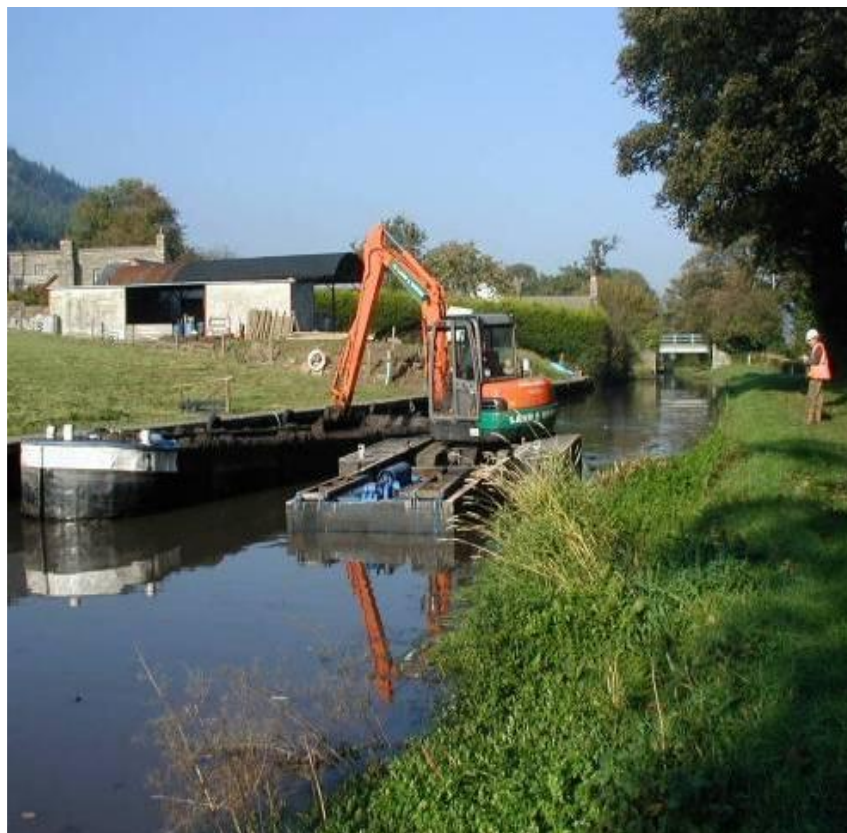
Annual Dredging Expenditure

1998/99	£500,000
1999/00	£1,685,000
2000/01	£2,778,000
2001/02	£3,773,000
2002/03	£6,817,000
2003/04	£4,950,000
2004/05	£2,230,000
2005/06	£4,649,000
2006/07	£5,132,000
2007/08	£4,770,000
2008/09	£2,978,000
2009/10	£3,453,000
2010/11	£3,546,000
2011/12	£3,742,000
